PLANNING TO FAIL

**Summary of Findings from Equal Education's Eastern Cape
School Visits, November 2016**

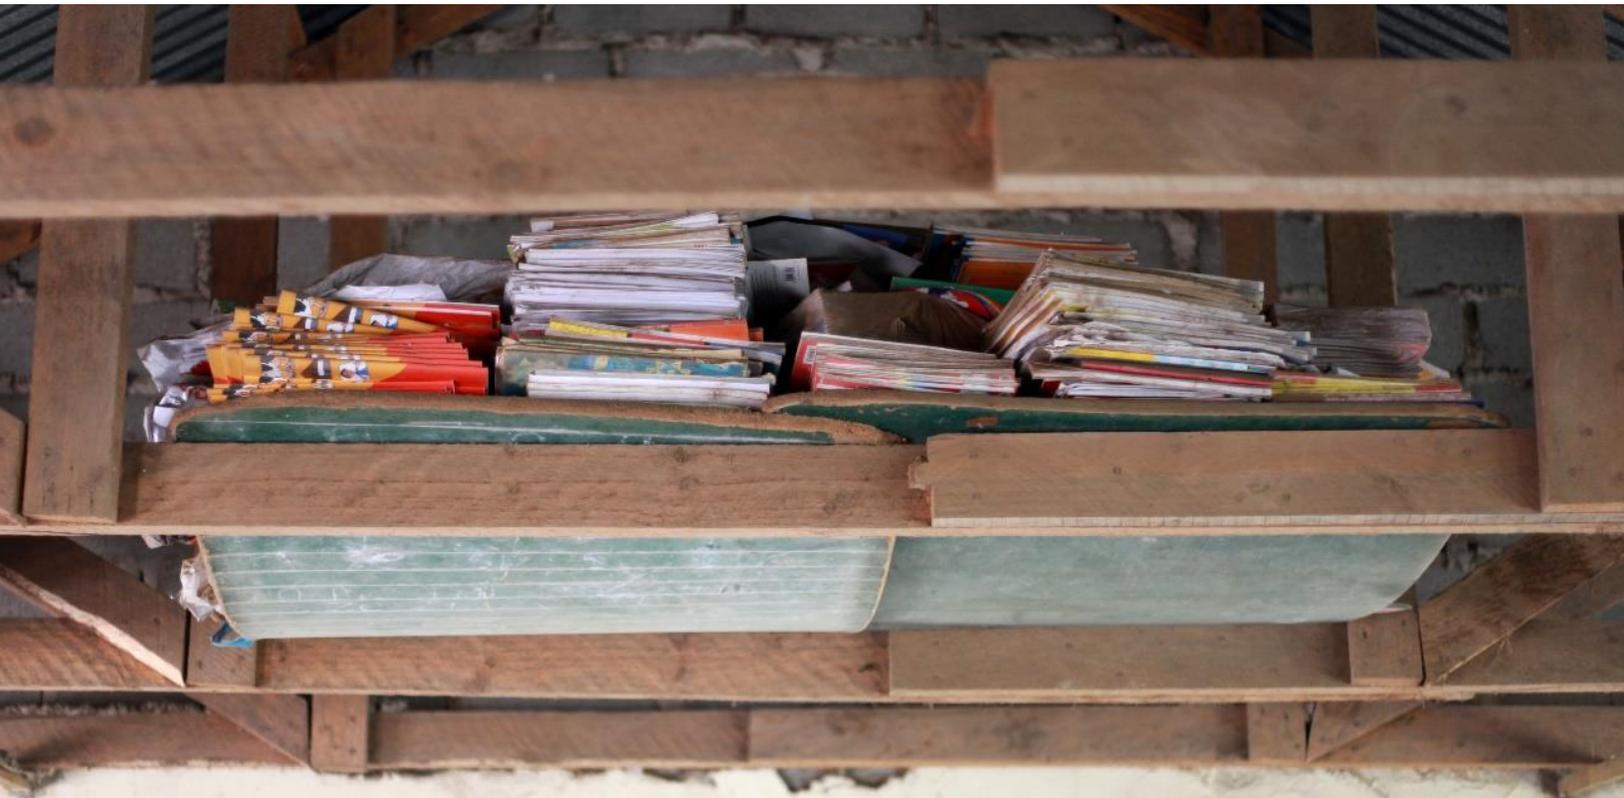
Cover image: Without a storeroom in the school, books in this mud classroom near Mbizana in the Eastern Cape are piled on chalkboards, balanced precariously between rafters above learners' heads. Credit: Muntu Vilakazi

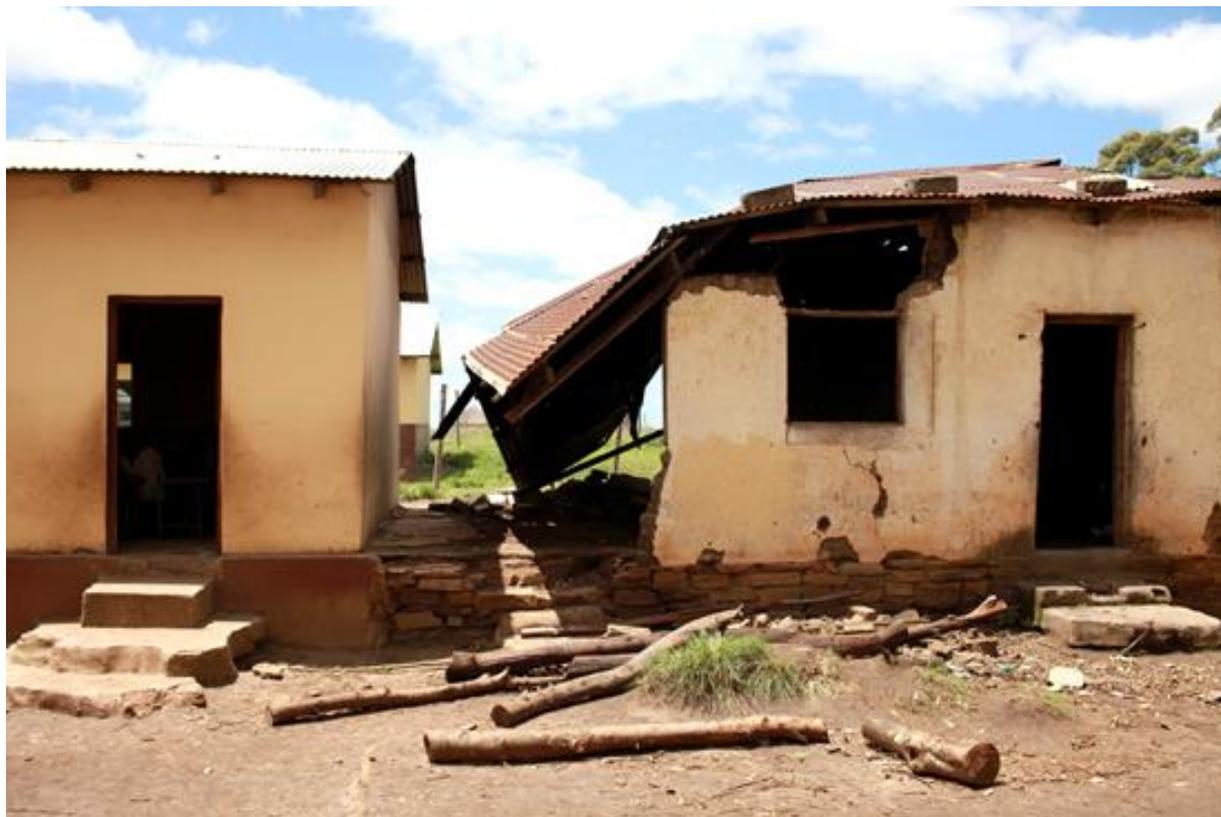
At Mjanyelwa Junior Secondary School in Kayamnandi, near Mbizana, children as young as five played in and around collapsed mud classrooms. There is one brick structure, but the school is

largely made of mud, and two of its classroom blocks have collapsed. This school is a danger to the teachers and learners who attend it daily. Mjanyelwa is not on any list for upgrades.

Above: A collapsed classroom at Mjanyelwa JSS

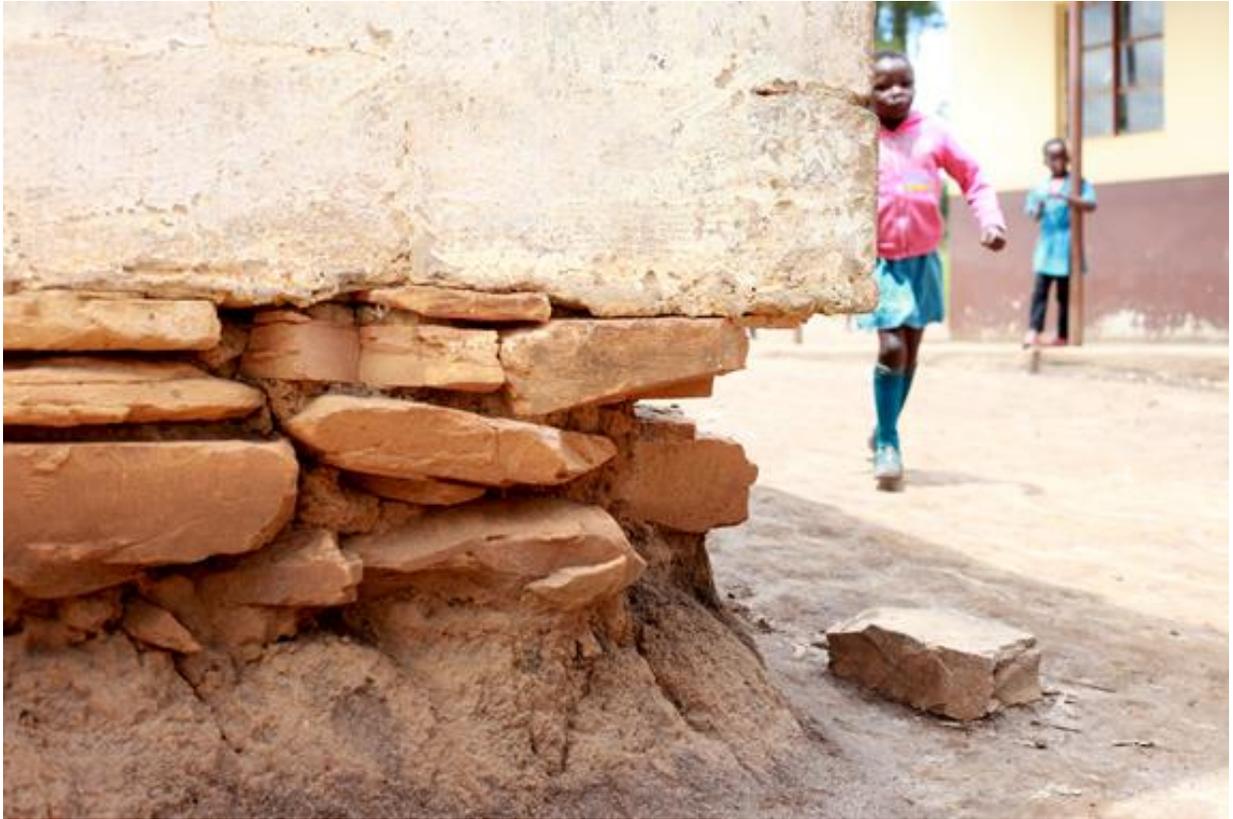
Above: Exposed foundations of a mud classroom at Mjanyelwa JSS

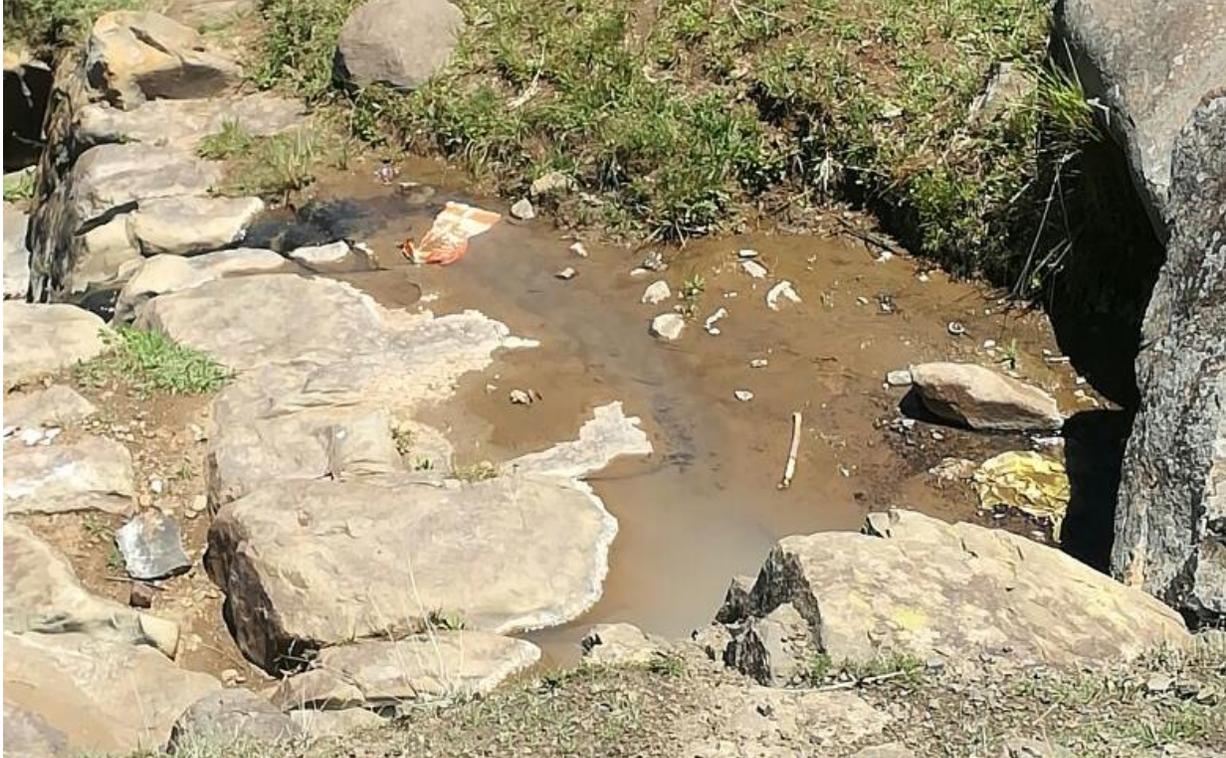
In other cases, the lack of accessible water forces schools to draw from nearby rivers. Caba Senior Primary School is one of several schools that has only one rainwater tank. When the tank runs dry, the task of collecting water from a river is delegated to learners. This is not only physically demanding, but also a drain on learners' available time to focus on studies.

Above: The polluted river where learners at Caba Senior Primary collect water

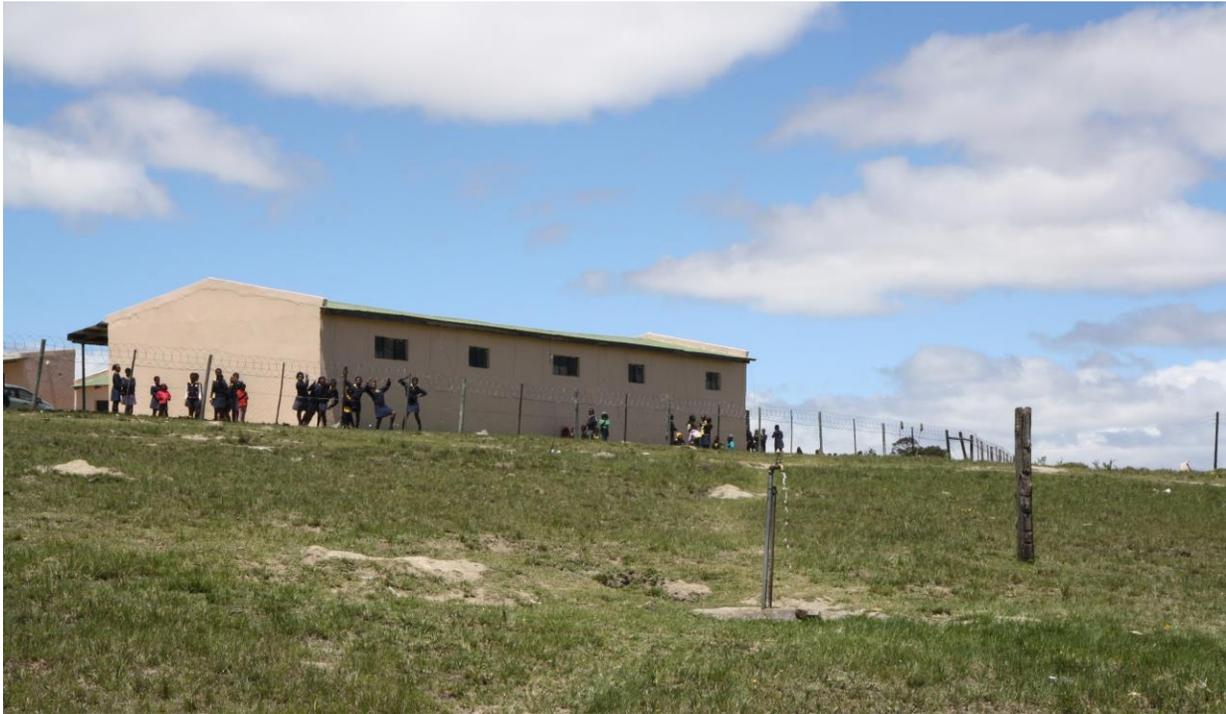
Above: At Tyinira JSS in Butterworth, learners rely on rainwater, yet a tap with access to water from the municipality exists meters outside of the school gates.

This example demonstrates the feasibility of installing working taps in rural schools. It reveals a category of schools where the DBE has clearly not done all it could: in villages which already have basic services, the local school is often left on the list of backlogs.

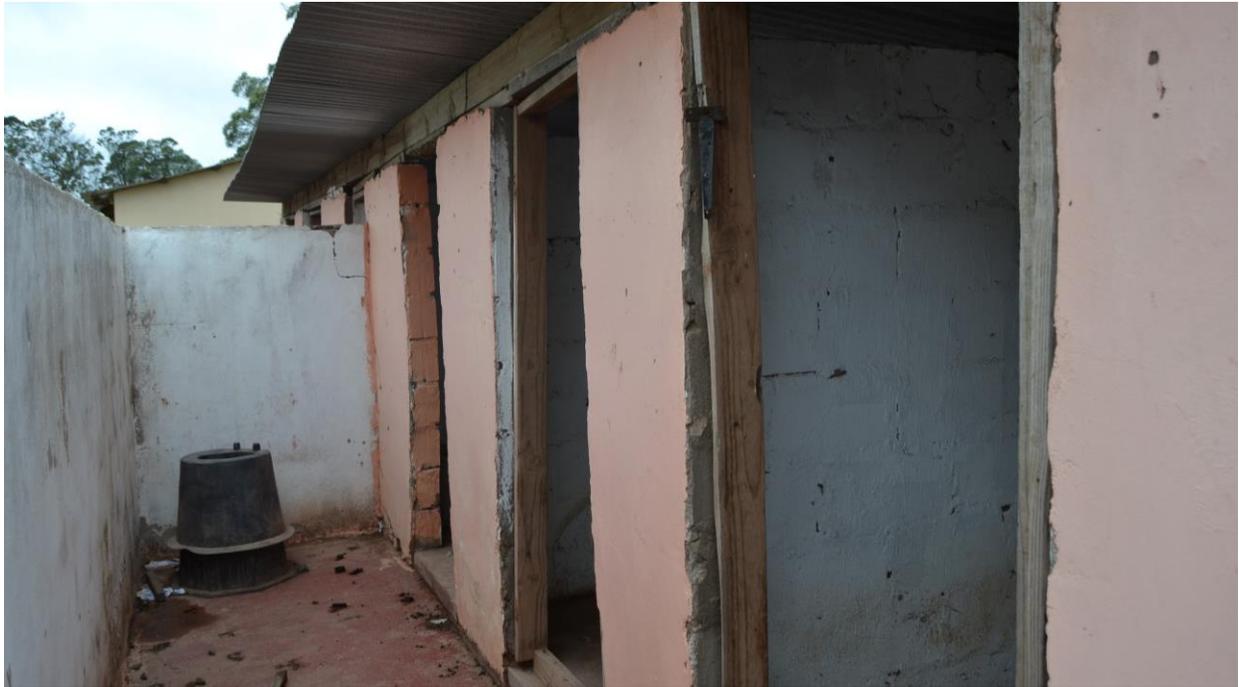
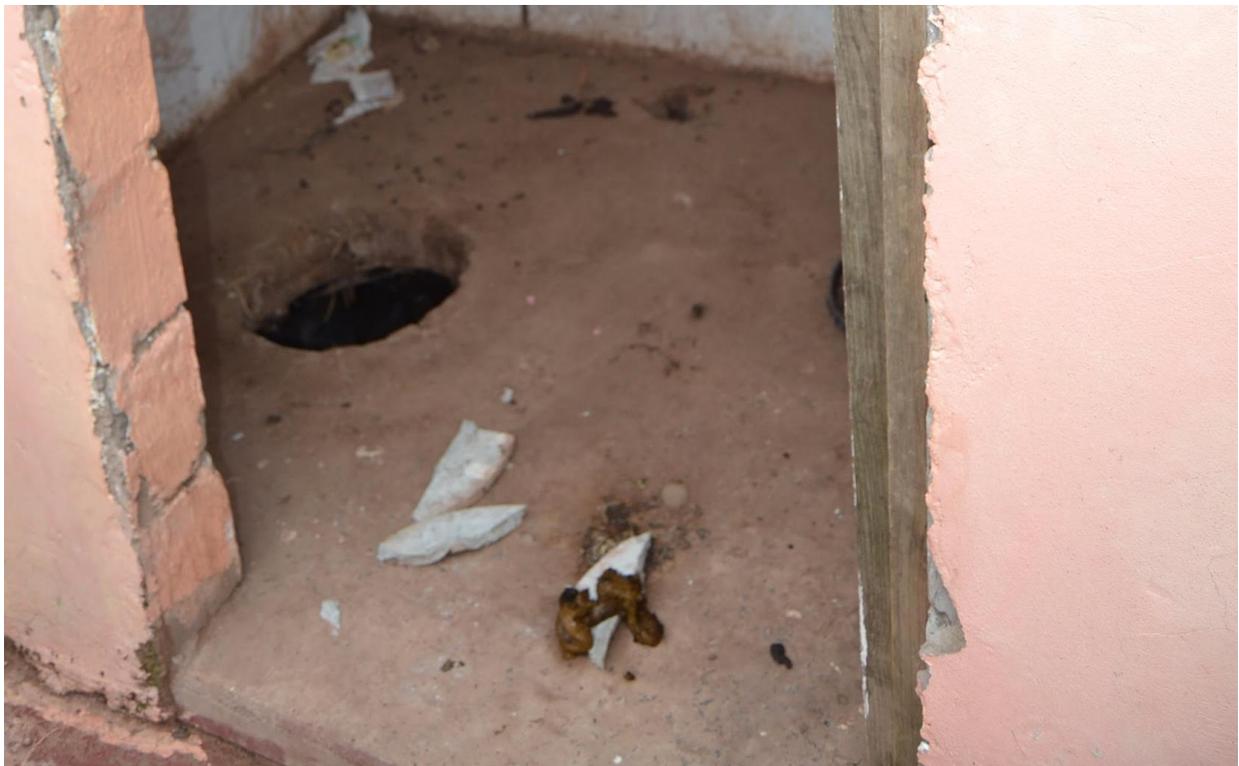
In Mthatha in the Eastern Cape, the principal of Lughogxo Junior Secondary worries that a Grade R learner may fall into a pit latrine. One “toilet” at this school is literally a hole in the ground. The ratio of toilets to learners is 1:49. The ratio of working toilets to learners is 1:294.

Above and below: At Lugxogxo Junior Secondary toilets are mere holes in the cement floor. Most toilets do not have doors.

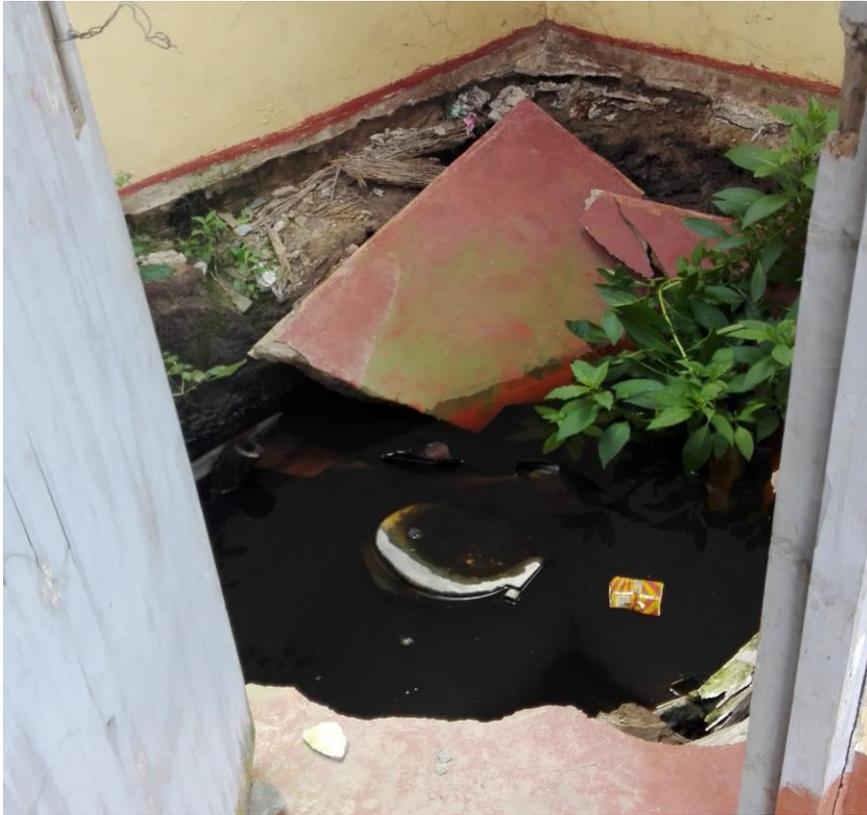
Left: Since Kalalo Primary caretaker Mr Sapepha fell into this pit more than a year ago, it has not been entirely closed off.

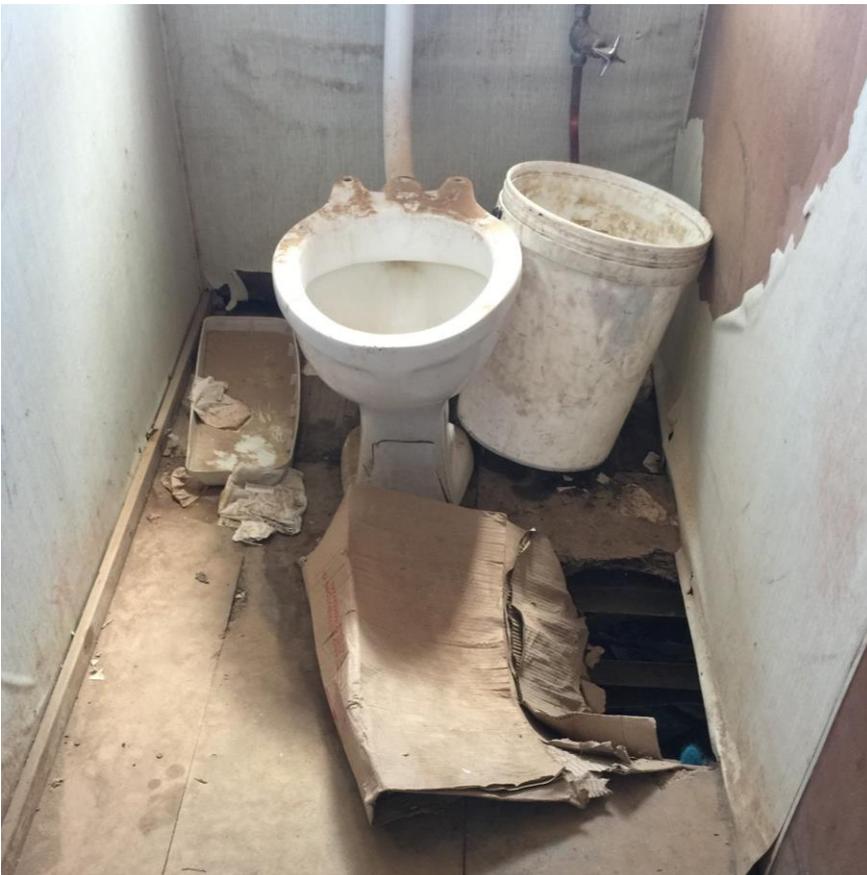
Left: The toilet in a Grade R classroom at Amatolaville Primary, and the hole created when the floor gave way beneath a teacher.

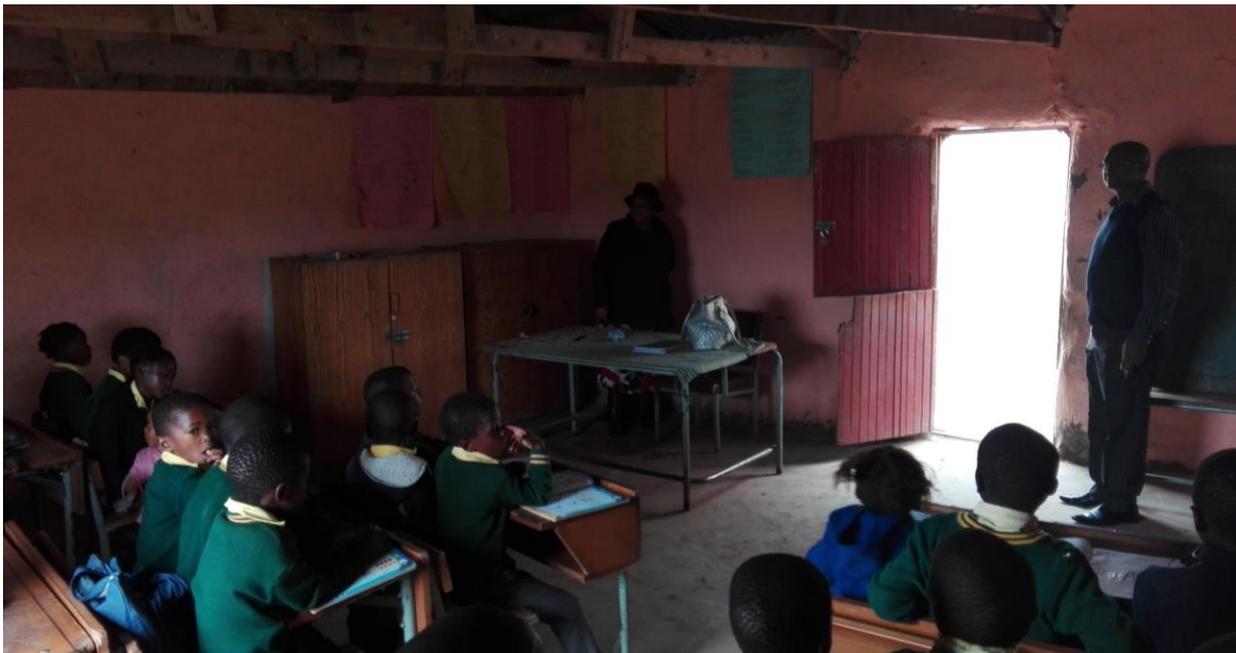
At Ngweni Junior Secondary near Mthatha, learners struggle to read teachers’ notes on makeshift chalkboards as sunlight barely makes its way into the dark, mud classroom. In some of the classrooms, the only source of light is the door and a small window behind learners. When it’s cold, teachers have to make a choice between adequate lighting and keeping the classroom warm. Absent any electricity, it is also impossible for the school to heat classrooms. According to the principal, Mr Sobantu, teachers and learners regularly get sick as a result.

Learners at Ngweni Junior Secondary battle to learn in dark and cold mud classrooms.

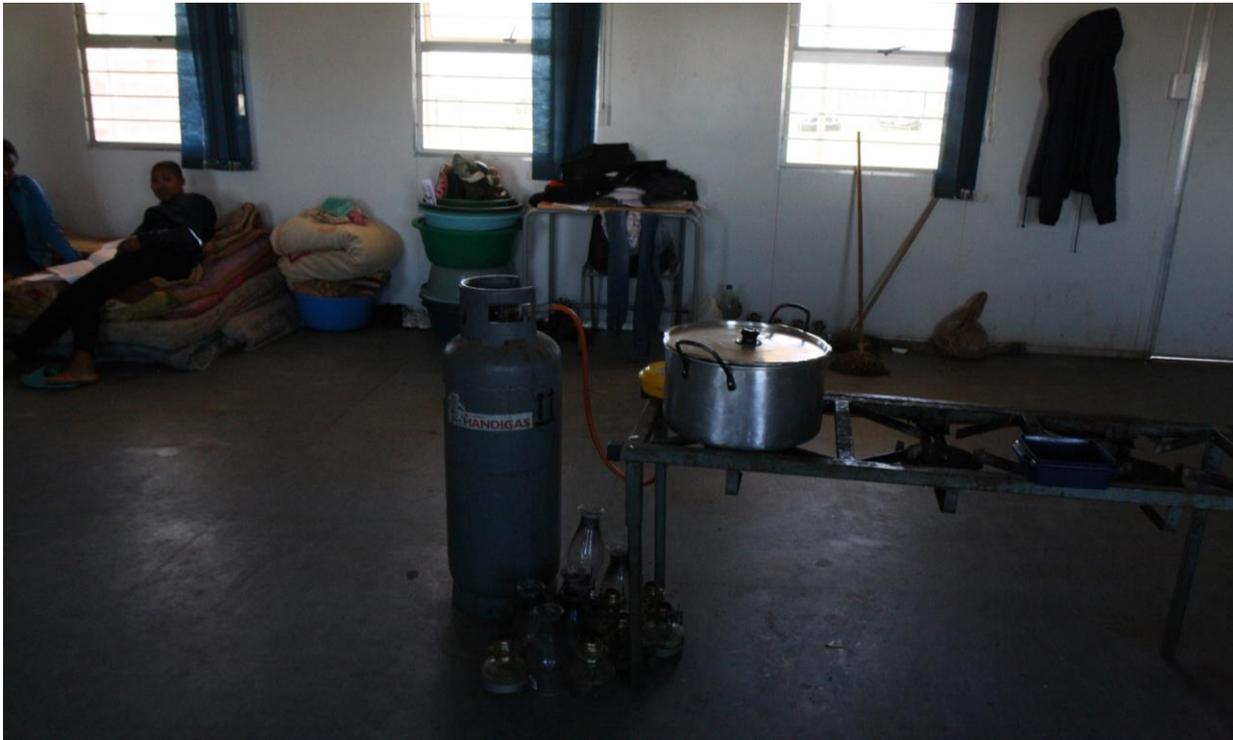
At another school, Ngubeszwe Secondary School near Butterworth, learners have to light paraffin lamps in order to study. As some of them overnight in the kitchen area of the school, they often have to use these lamps close to flammable gas tanks.

Above: A lack of electricity can pose serious safety risk to learners at Ngubeszwe Secondary School

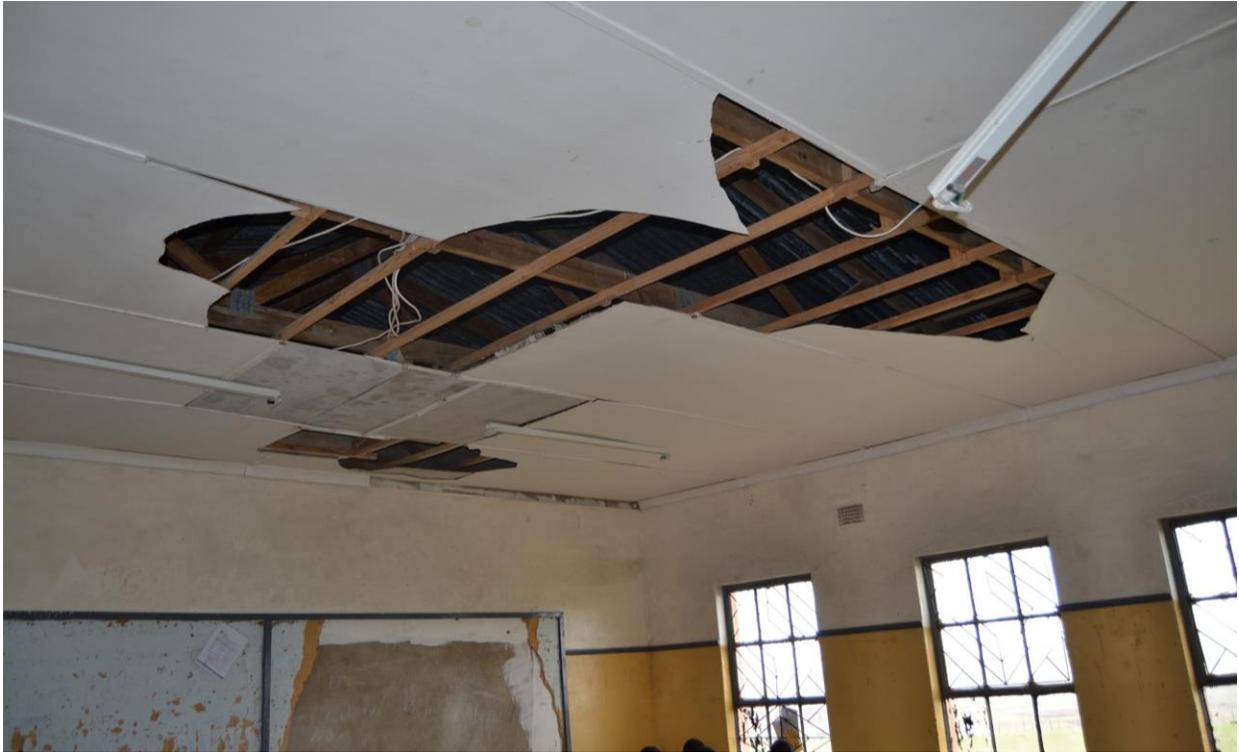
EE also encountered schools where electrical wiring had not been properly planned for and installed. This was exacerbated by poor infrastructure, where collapsing ceilings and walls exposed the wires. Such situations are particularly dangerous when roofs leak and can result in short circuits.

Wires hang from the roof at Ngweni Primary School near Mthatha after parts of the ceiling in the only brick building collapsed.

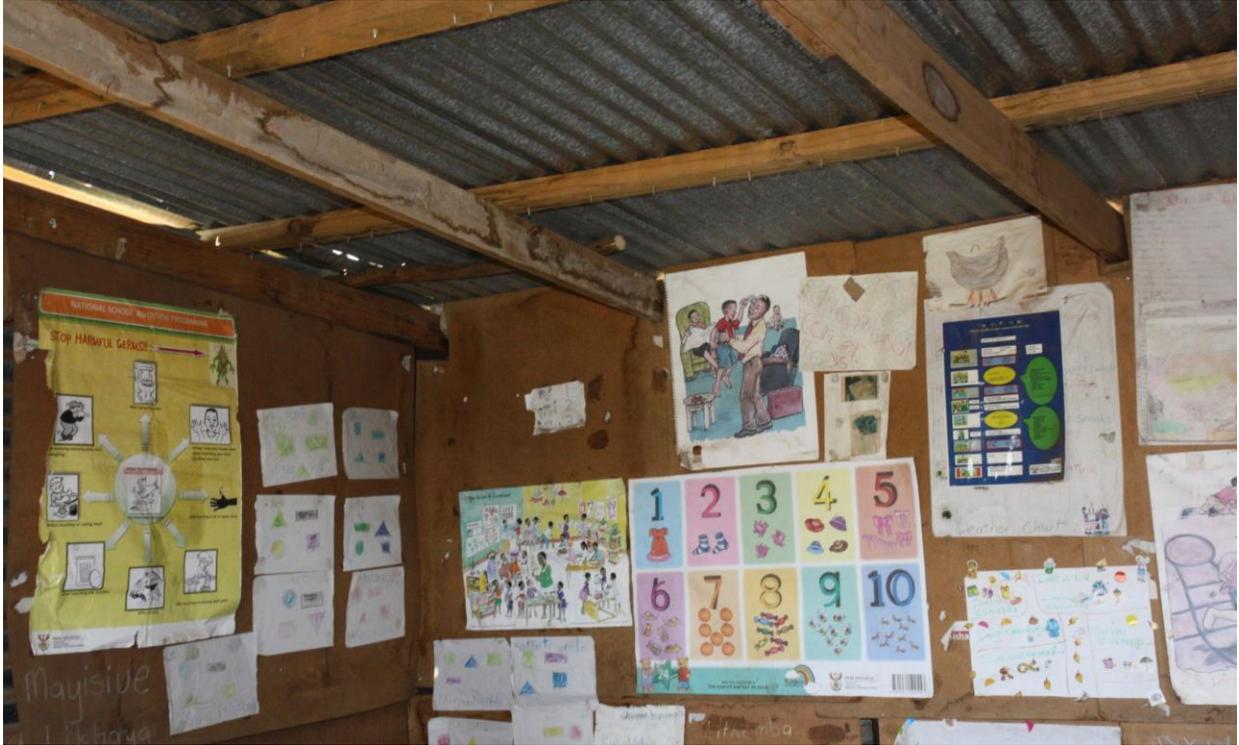
Siseko JSS has 276 learners spanning from Grade R to Grade 9. The Grade R classroom is made entirely out of zinc, and the rest of the classrooms are made out of mud. Both materials are considered inappropriate in terms of the Minimum Norms and Standards for School Infrastructure. When it rains, it becomes very difficult for the young learners to continue with classes. Already classrooms are packed, with Grades 2 and 3 learning together in a single classroom, and Grades 5 and 6 doing the same.

Above: Inside the Zinc Grade R classroom at Siseko

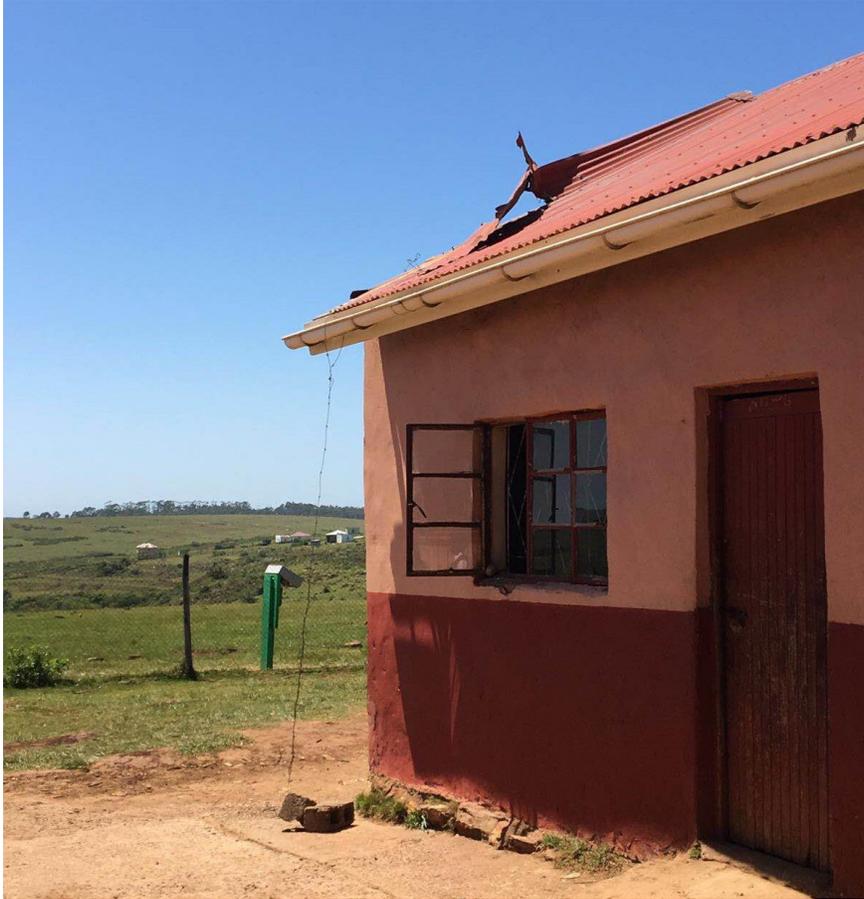
The principal identified three structures at Siseko JSS that, without upgrades, are currently at risk of collapsing. The zinc roof of three structures has been destabilised due to windy and rainy conditions. In order to mitigate the risk of the roof falling in, the principal used bricks as makeshift weights to hold the material in place.

Left: The roof at Siseko JSS that is held down by two bricks

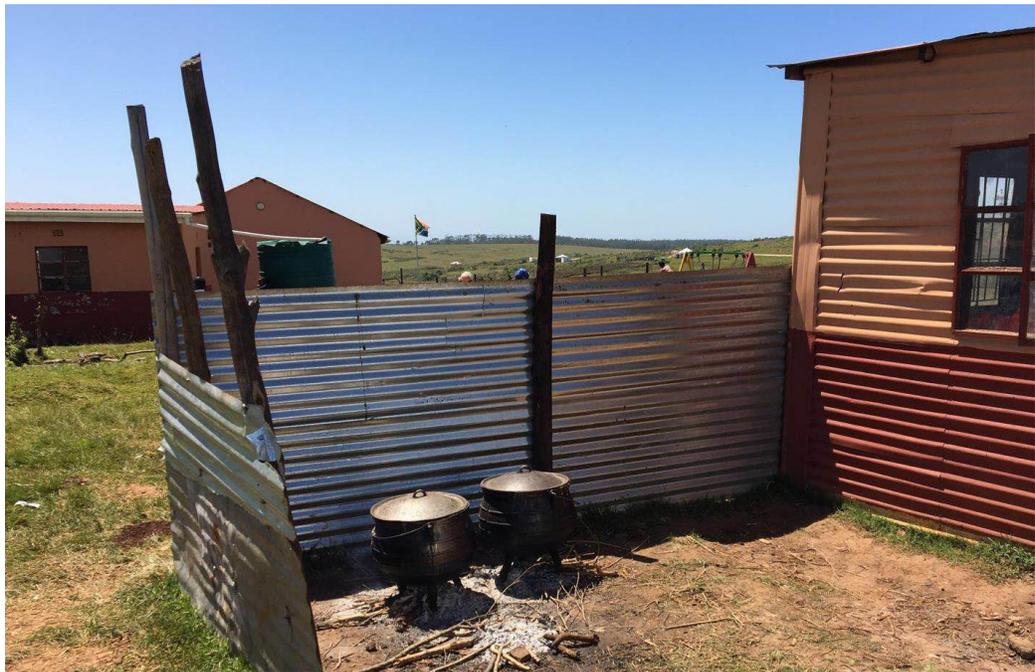
Siseko JSS does not have a kitchen. Instead, two pots sit on the ground outside for the school’s two cooks to prepare food. The women use water from a Jojo tank that collects rainwater. When there is no rainwater, the ladies fetch water from a river. We watched as pigs and dogs, which roam the school grounds, sat next to the unprotected, prepared food. A storeroom next to the kitchen is used as a library, a staff room, and a makeshift kitchen for staff members.

Right: The space outside of Siseko JSS that is used as a kitchen.

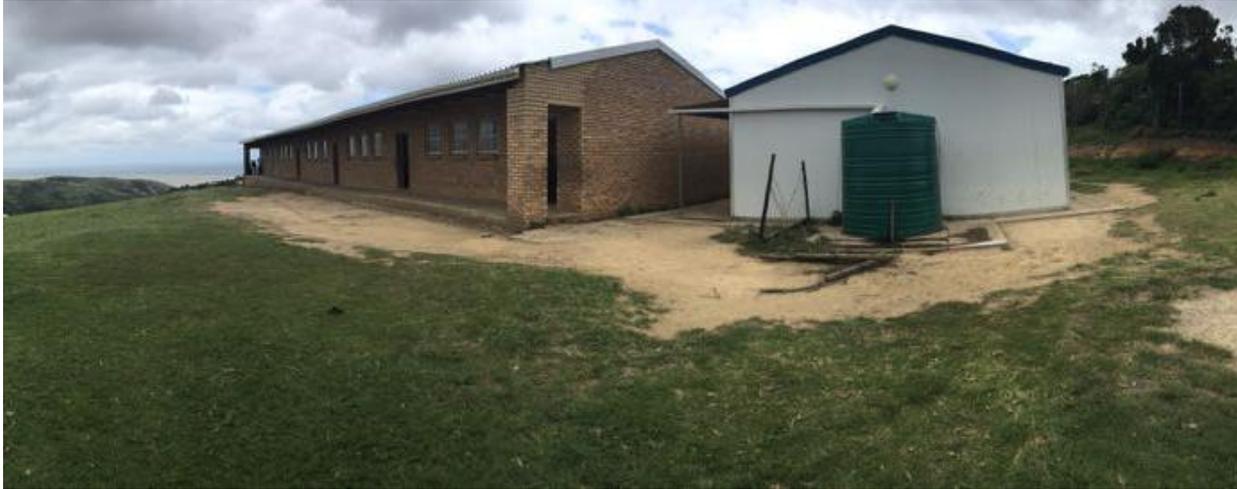
Despite recent interventions regarding infrastructure, Noqhekwana still has no electricity connection. As of 29 November 2016 this will be in violation of the Uniform Minimum Norms and Standards for School Infrastructure. In overcast conditions, classrooms are dark which affects teaching and learning.

Above: In overcast conditions classrooms at Noqhekwana Junior Secondary are very dark.

Neither the DBE nor the ECDOE has taken any steps to provide interim access through the form of either solar energy or the installation of a generator. The school does not even appear on the ECDOE plans with regards to their implementation of the Uniform Minimum Norms and Standards for School Infrastructure.

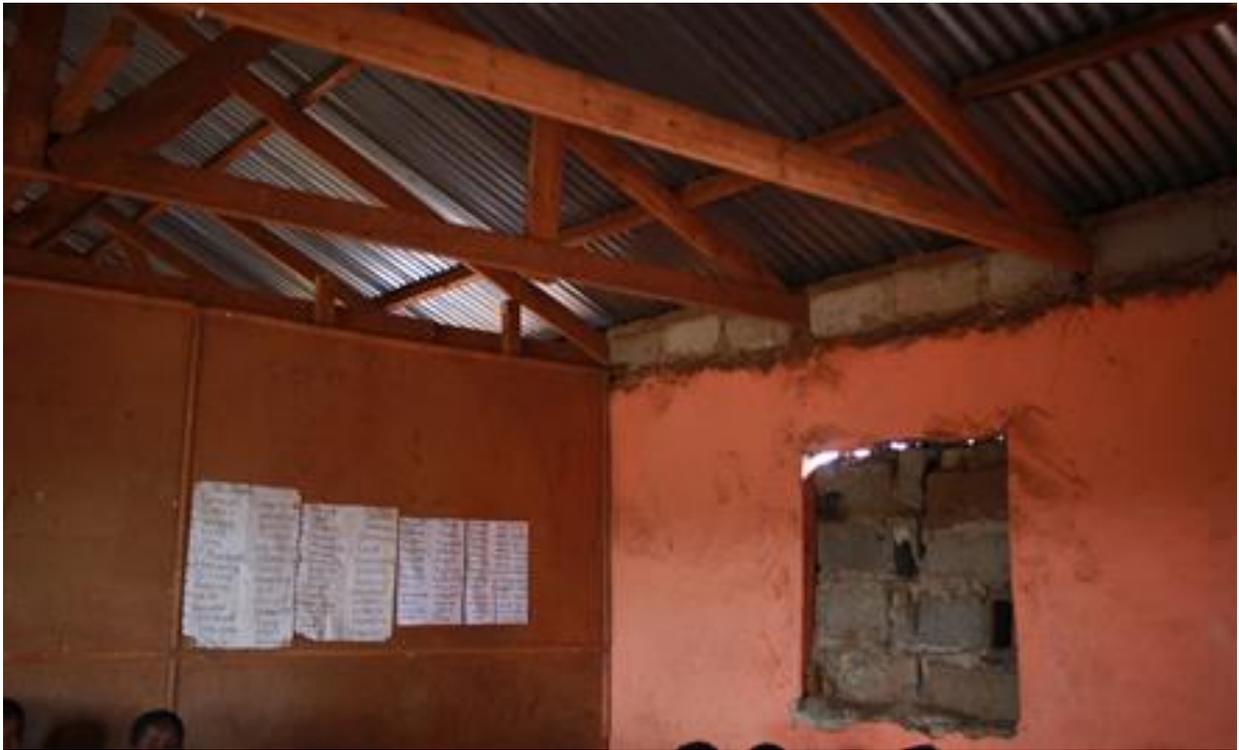
Above: The interior of a mud-cement classroom at Mbabazo SPS

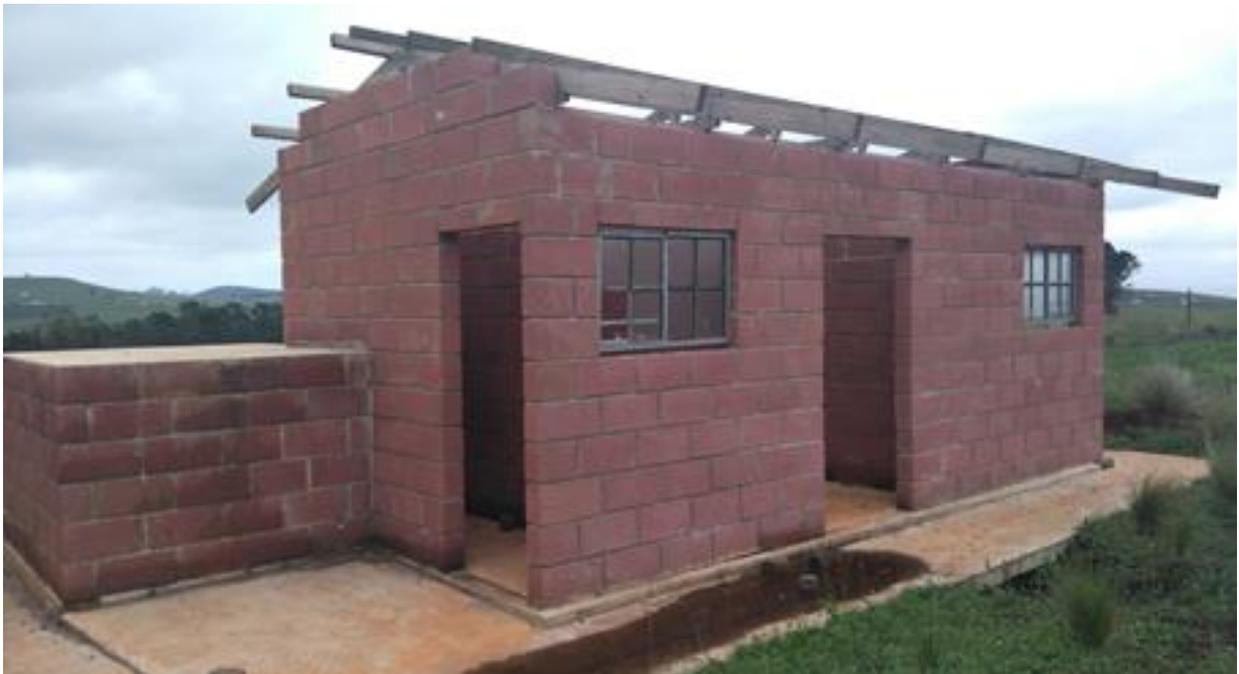
Above: This toilet block was never completed

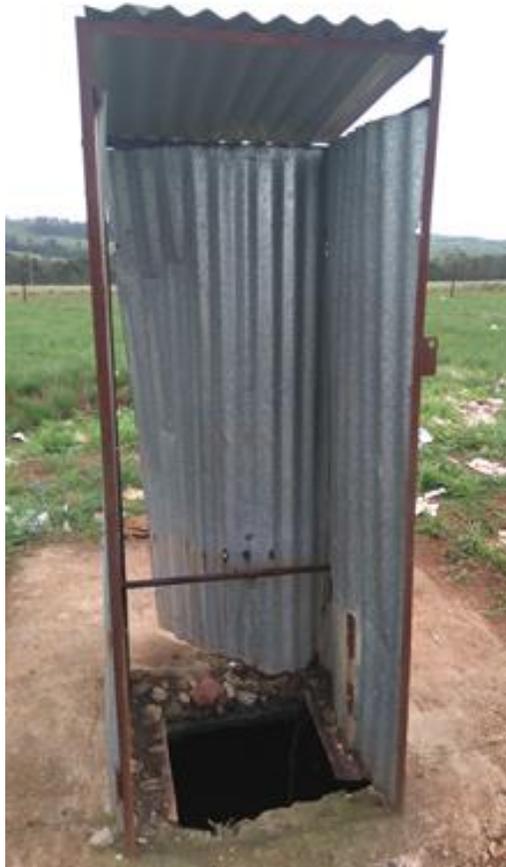
Nearby stand the school's three functional pit latrines, which must serve over 300 learners. There are also two derelict zinc latrines. Time has left gaping holes where there were once toilet seats. In a school which accepts Grade R learners, there is no barrier to stop young children from falling into the holes.

Above: A derelict latrine

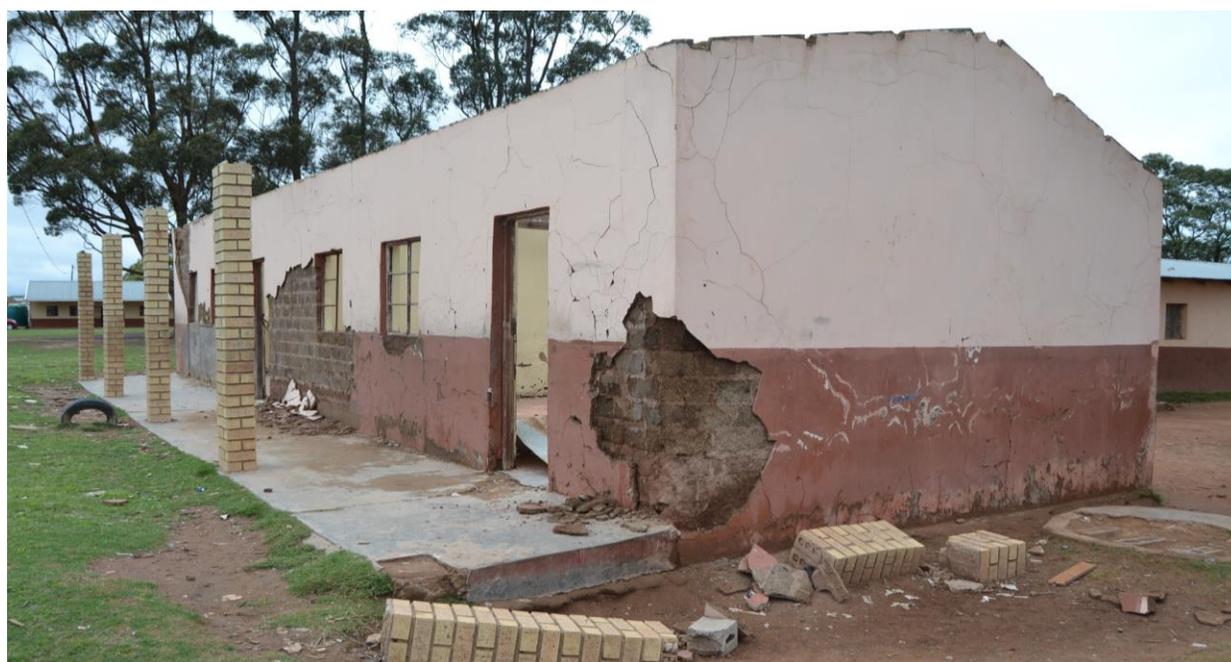
The school only has one toilet for every 49 learners, but when one consider the number of working toilets, this ratio escalates to a shocking 294 learners per working toilet. What’s more, after 29 November Lugxogxo JSS will constitute a violation of the law, as it is substantially built of inappropriate material. One block of classrooms is made entirely of life-threatening asbestos and another of mud. A third block collapsed during a storm in February this year. The department has not offered any assistance with emergency classrooms since the incident.

Above: A block of classrooms collapsed during a storm in February this year. The school is yet to receive emergency classrooms

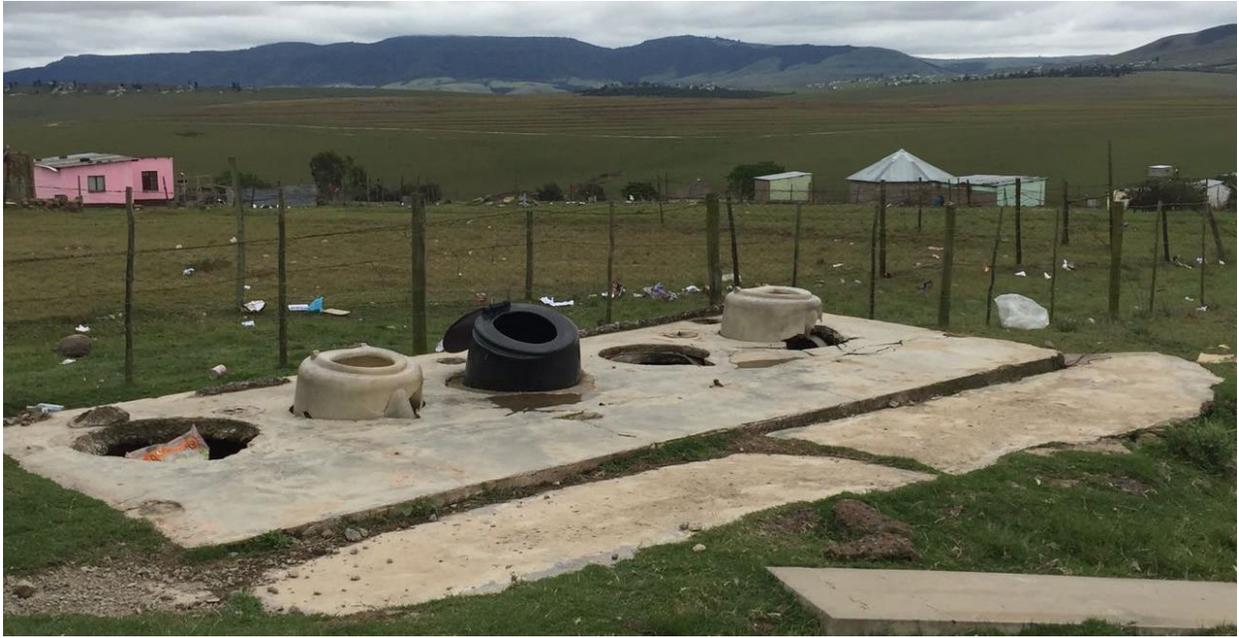
Lutholi has limited access to water (through rainwater collection) and is forced to buy water once a month from Mthatha. More jarringly, the school has 1 block of toilets with no walls or doors. This block is next to the girls toilets and is thus used by girl-learners. By the boys' toilets, the remains of two former toilet blocks stand. The pits are open and exposed.

Boys urinate in the pits instead of the toilets. This is dangerous, the pits being easy to fall into. The toilets that do exist are small in number and in poor condition. The small number of them forces learners to use the open pits/and open toilets. There is 1 toilet for 70 male learners.

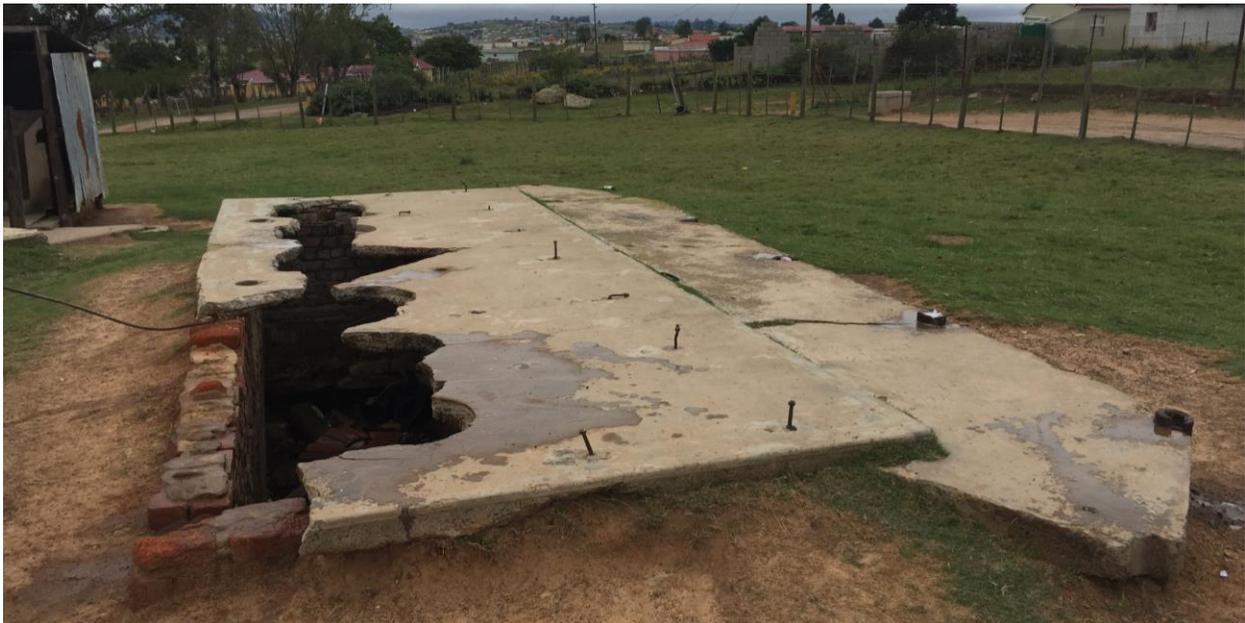
Above: Collapsed pit latrines used by learners as urinals.

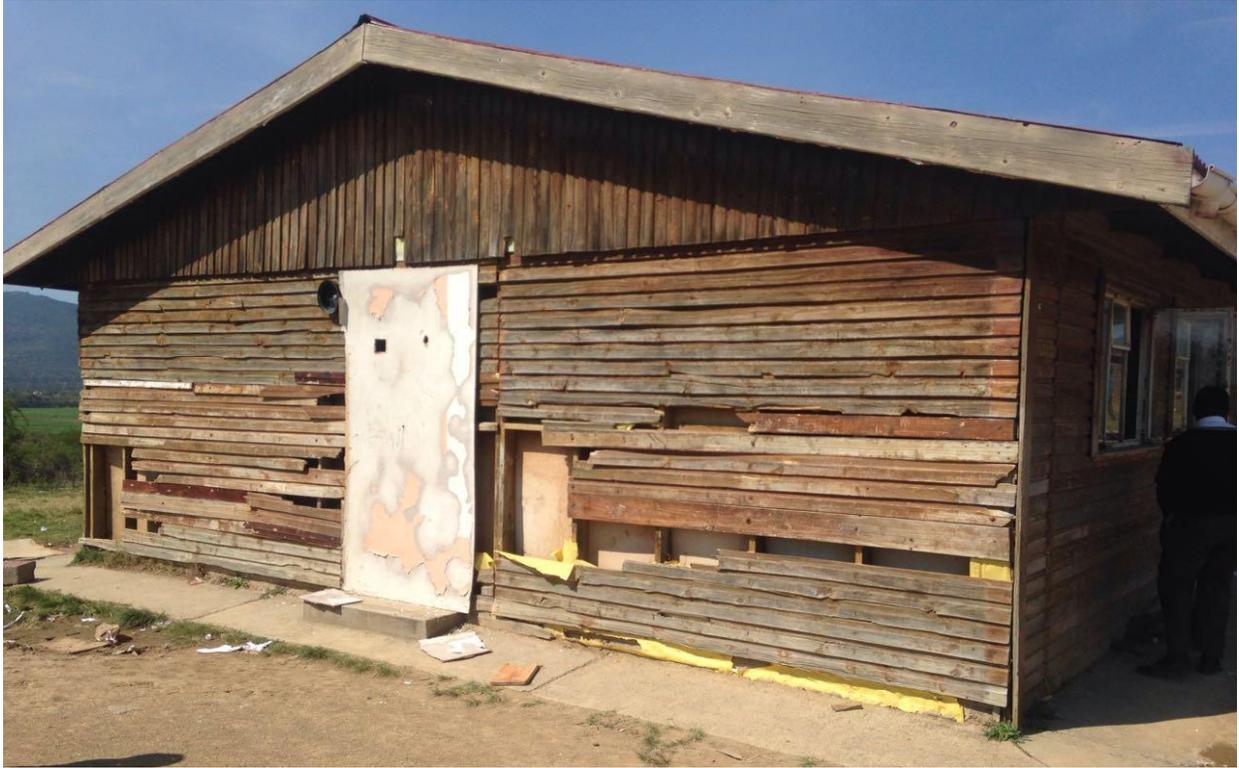
Above: Wood classrooms at Vukile Tshwete Secondary School.

As far as the principal knows, an entirely new school will be built where the zinc pit toilets and dilapidated classrooms now stand. Construction should already have begun, but was unexpectedly postponed to next year. It was communicated to the principal that this was because of problems with the tender awarded for the construction work.

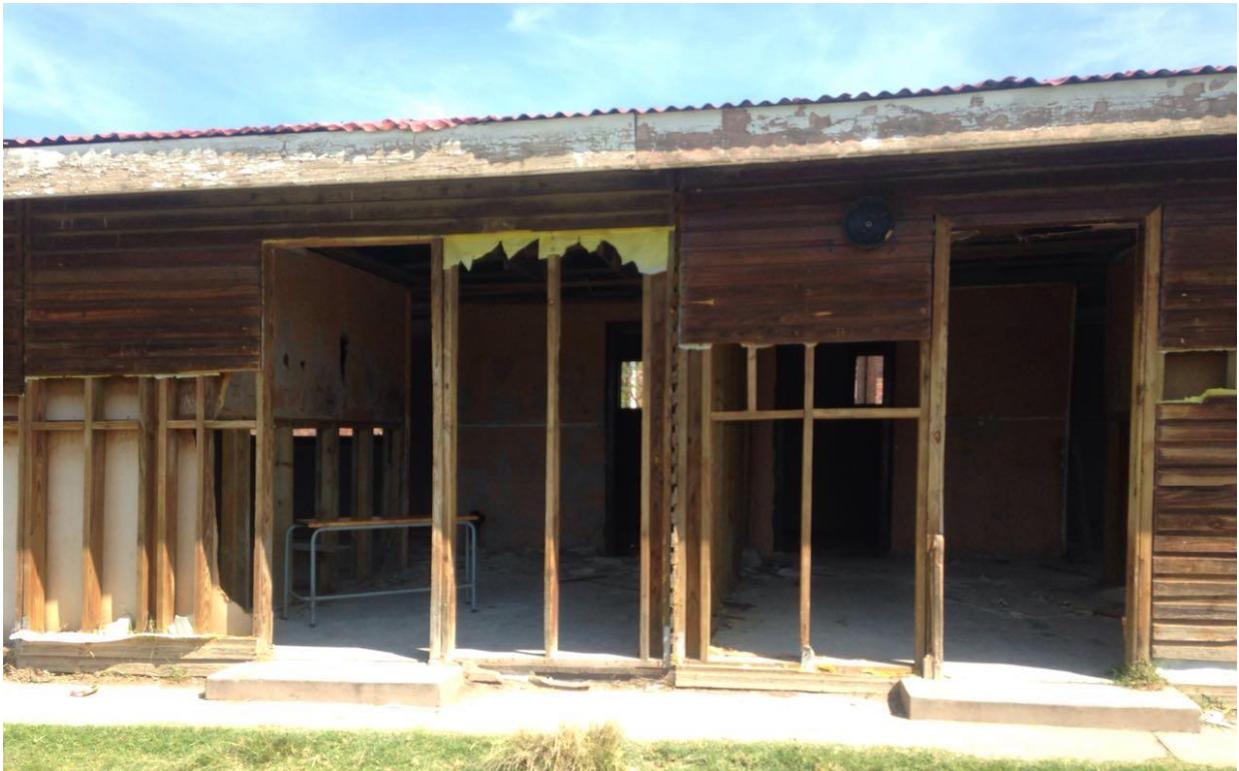
Above: Classrooms at Vukile Tshwete Secondary have fallen apart entirely.
