PLANNING TO FAIL

**Summary of Findings from Equal Education's Eastern Cape
School Visits, November 2016**

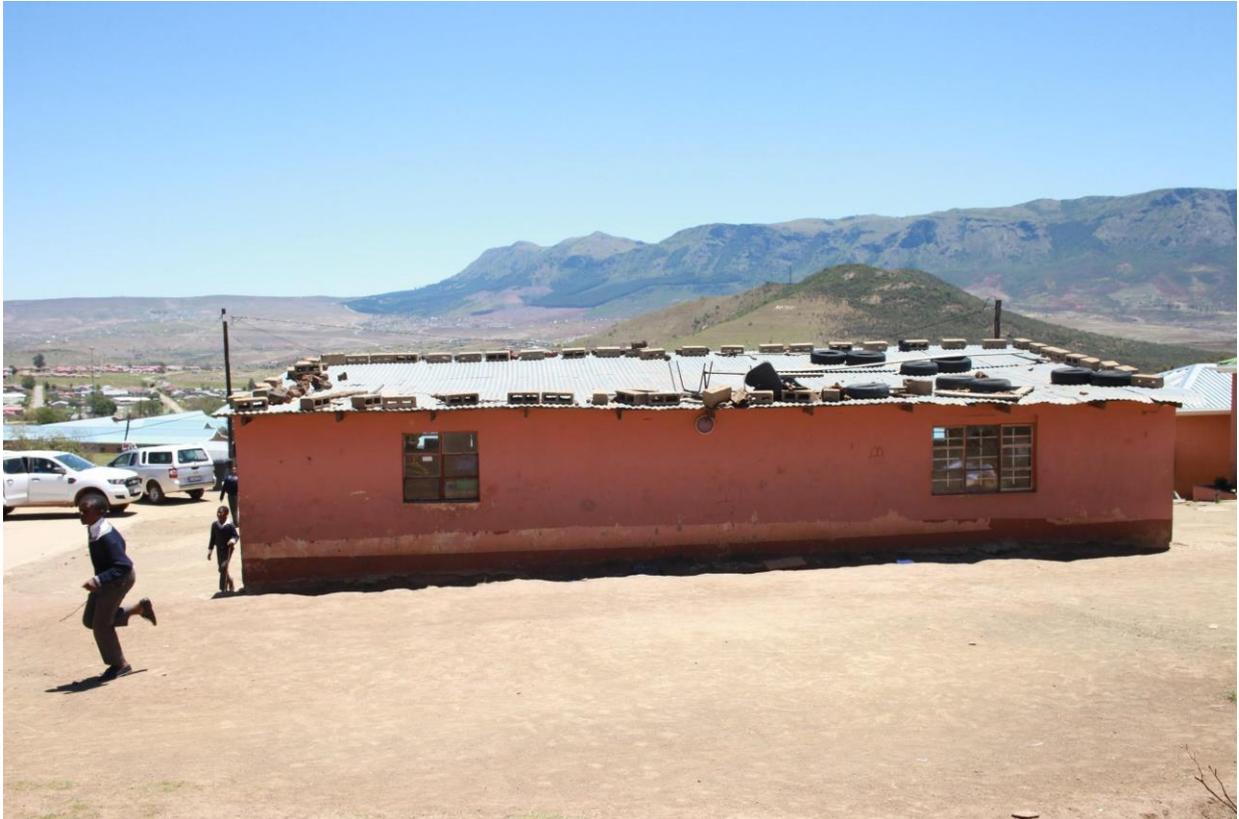
Above: One of the mud classrooms at Mount Ayliff Hospital JSS. The ceiling is secured with bricks and tyres.

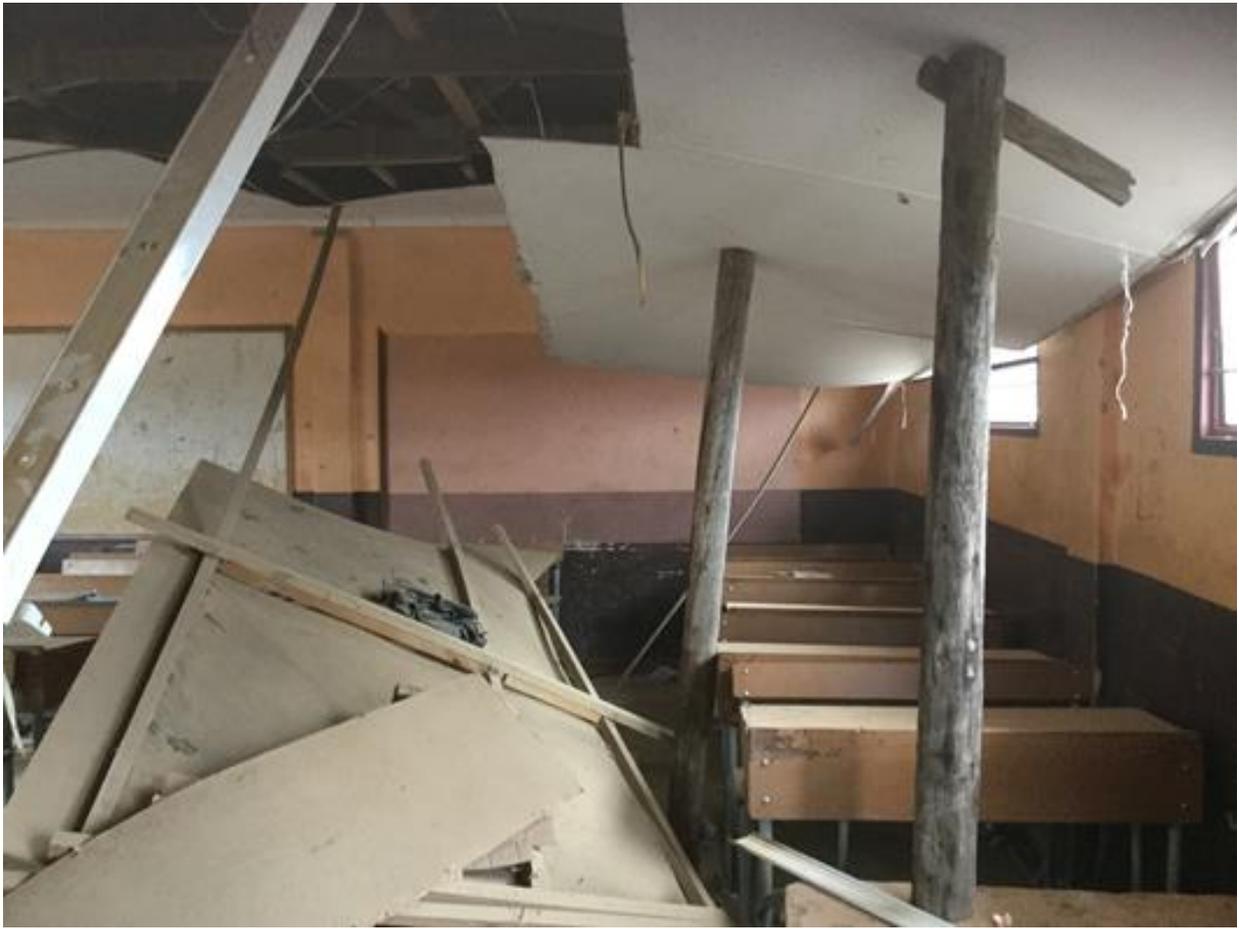
Above: The collapsed ceiling at Mount Ayliff Hospital JSS. Learners were exposed to asbestos dust from the roofing, electric wiring and chunks of concrete.
